ULTRACLEAN
ELECTROPOLISH, INC.

The In Situ Vessel Remediation Specialist

Photomicrographs: **304 Stainless Steel, magnification 1500x**

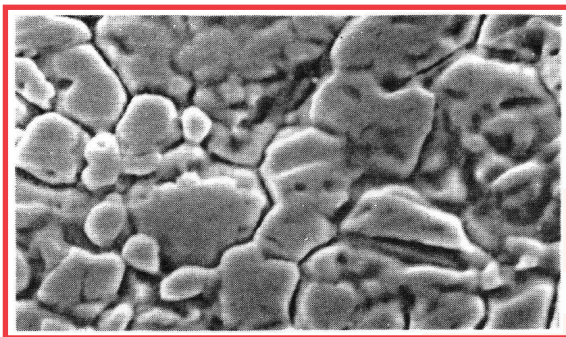
No 2B Mill Finish before electropolishing.

Note grain boundaries, which offer excellent sites for contamination such as bacteria to become embedded.

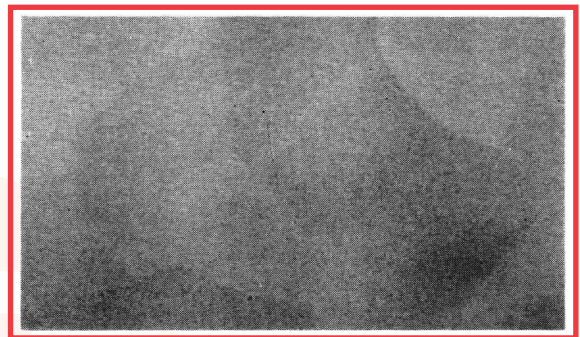
No 2B Mill Finish after electropolishing.

Note that grain boundaries have been removed, eliminating sites for contamination to be retained.

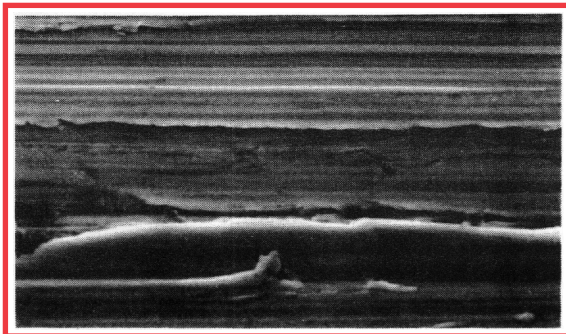
Mechanically polished No. 4 Finish before electropolishing.

Note deep crevices and torn material, which offer excellent sites for contamination such as bacteria to become embedded.

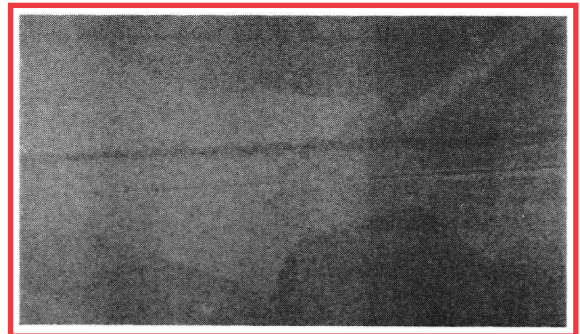
Mechanically polished No. 4 Finish after electropolishing.

Note deep crevices and torn material have been removed, eliminating sites for contamination to be retained.
