TESTS ON ROUGING AND EXPERIENCES DEALING WITH ROUGING IN PHARMACEUTICAL PRODUCTION

Part 2 of this article describes tests and practical experiences in rouging formation and the influence of rouge coatings on cleaning efficiency.

The present technical article (in 3 parts) discusses the current body of knowledge on the subject of rouging. It is based on insights from tests and operating experiences of companies that manufacture pharmaceutical medicinal products.

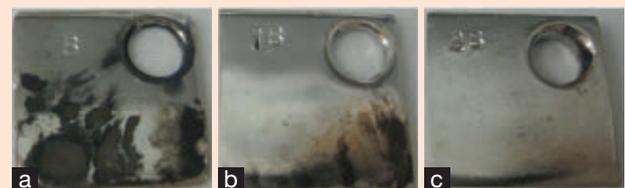
Figure 1 Test plates after an exposure time of 824 days

After an uninterrupted exposure time of 824 days, the test plates exhibited non-uniformly formed black, partly brownish discolorations (Figure 1). These discolorations exhibited only slight similarities to the rouge coatings observed on media-contacted surfaces of clean steam systems after prolonged operating times.

(a) material 1.4571 (b) material 1.4435 (c) material 1.4539

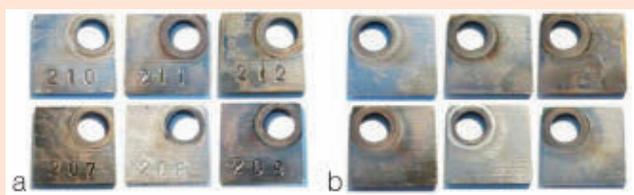
Figure 7 Test plates of 1.4435

(a) front side and (b) back side – arrangement analogous to (a). Note: 210, 211, 212 is upper zone of tank; 207, 208, 209 is lower zone of tank. 208 and 210 were subjected to derouging

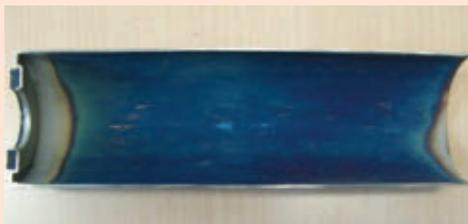
Figure 12 Filter of WFI system with discolored bluish inside surface

A comparable result was found on a filter from a WFI system. The filter had been in service for approximately 6 months at 80°C, in a flow arriving from the inside. The outside surface has a slightly brownish appearance, while the discoloration of the inside surface is predominantly bluish (Figure 12). Only the attachment zone and the tip are metallically bright. The SEM investigation undertaken revealed that the bluish surface is formed from a closed layer consisting of many fine crystals. The average crystal size is approximately 0.2 µm. In contrast, only individual particles with a size of 0.1 µm can be observed in the metallically blank zone (Figure 13).

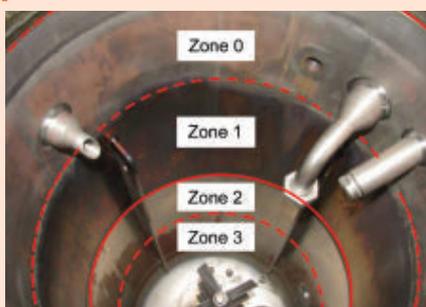
Figure 16 | Classification of the interior space of the test tank into zones with different rouge formation

With increasing number of cleaning/sanitizing cycles, the rouging increased distinctly and the inside surface of the test tank exhibited an increasingly intensive reddish-brown color over the test duration. Four zones with rouging of different intensity and stability were formed (Figure 16).

- ▶ Zone 0: no externally applied heating jacket
- ▶ Zone 1: externally applied heating jacket
- ▶ Zone 2: externally applied heating jacket, below the liquid level, without migration rouge
- ▶ Zone 3: externally applied heating jacket, below the liquid level, with migration rouge

The formation of these different zones was explained by different heat influences of the heating jacket and by the times of exposure to the various media (sodium hydroxide solution, clean steam).
